# Occupational Exposure To Polychlorinated Dioxins, Polychlorinated Furans, Polychlorinated Biphenyls, and Biphenylenes after an Electrical Panel and Transformer Accident in an Office Building in Binghamton, NY

by Arnold Schechter\* and Thomas Tiernan†

A polychlorinated biphenyl (PCB) and tri- and tetrachlorinated benzene-containing electrical transformer was involved in an explosion and fire in a modern office building in Binghamton, New York, on February 5, 1981. Because of an unusual system of air shafts the entire building and adjacent garage became contaminated with toxic chemicals. Polychlorinated dioxins, furans, and biphenylenes were formed as pyrolytic by-products. Before the extent of the chemical contamination was appreciated workers were exposed to these chemicals. Four years after the explosion and after the expenditure of over \$22 million for cleaning and other expenses, the building remains closed.

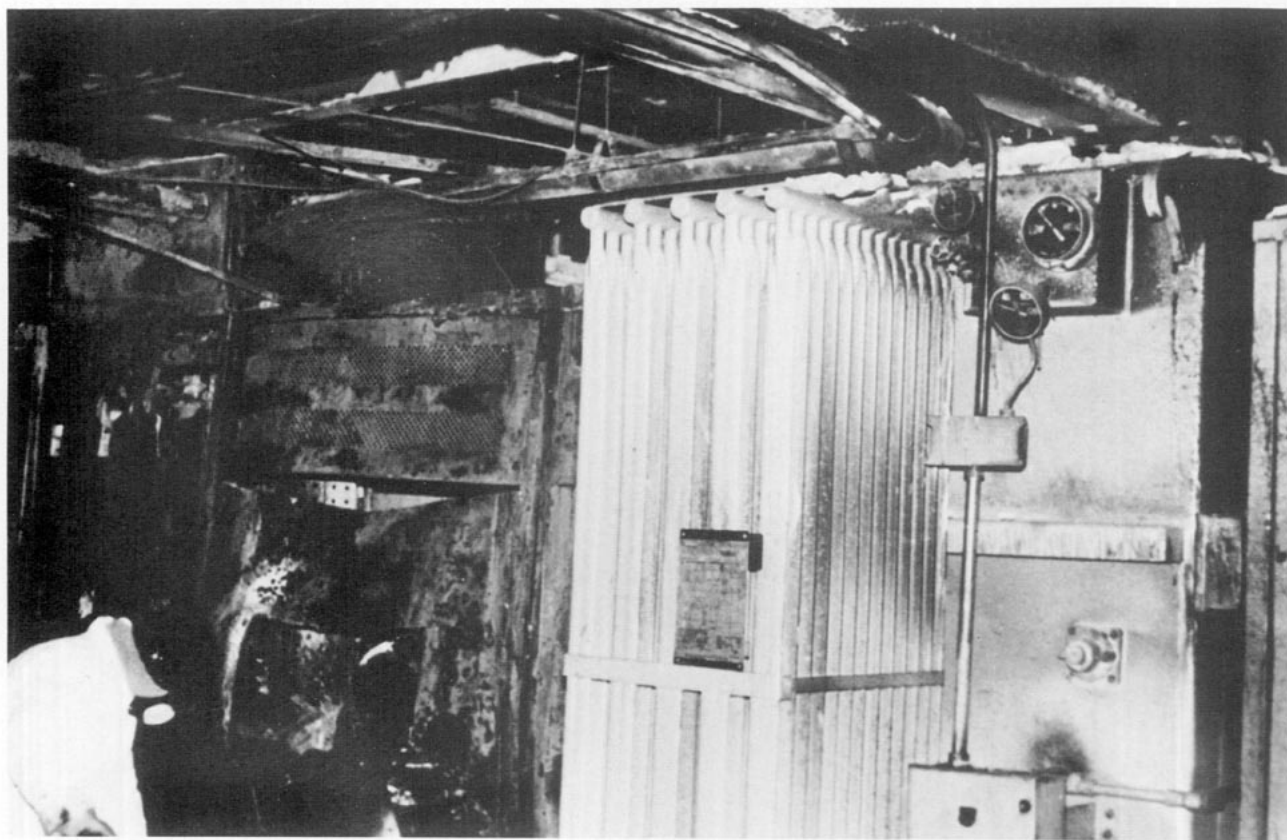
FIGURE 2. The damaged electrical panel is seen on the left behind a clean up worker. The damaged transformer is to the right of the panel. Soot is apparent on the panel and ceiling where burned wires and insulation are seen.

The affected transformer (Fig. 2) was located in the

basement of the Binghamton State Office Building, which is one of four government buildings, including the Broome County Building, Binghamton City Hall and the Binghamton City Council Building, sharing a common basement and subbasement level parking garage. Air

shafts in the ceiling of the transformer room extended to the top of the 18 story Binghamton State Office Building. These shafts ventilated the two bathrooms on each floor of the building and opened to these rooms by a small opening covered by a metal grating. During the

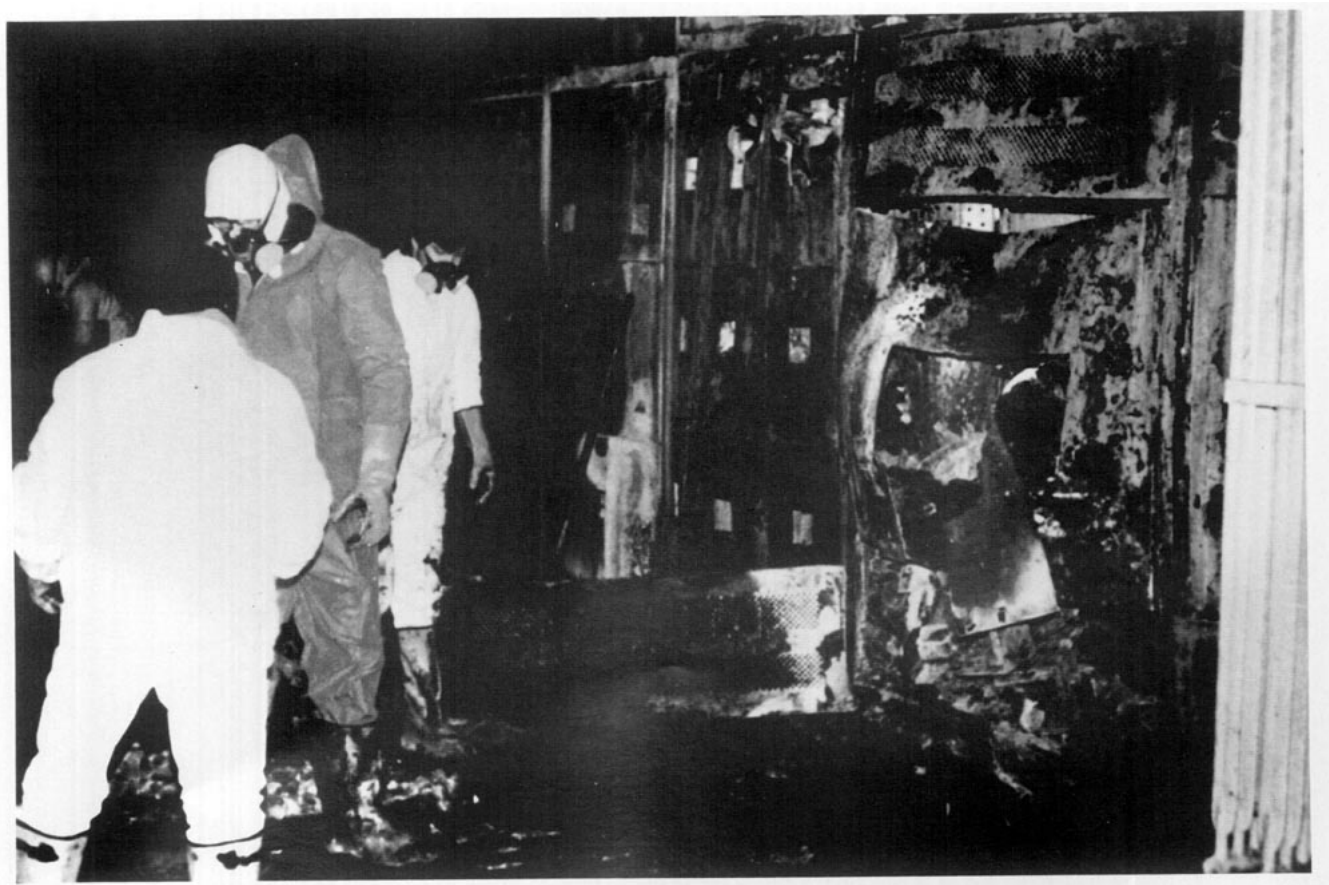
FIGURE 3. This photograph shows the damaged, soot-covered, electrical panel and several workers wearing different sorts of protective clothing over their street clothing. Respirators with cartridges filtering air and particulates are apparently being worn by these workers but full facial protective masks or oxygen breathing apparatus are not being used. These photographs were taken in February 1981.

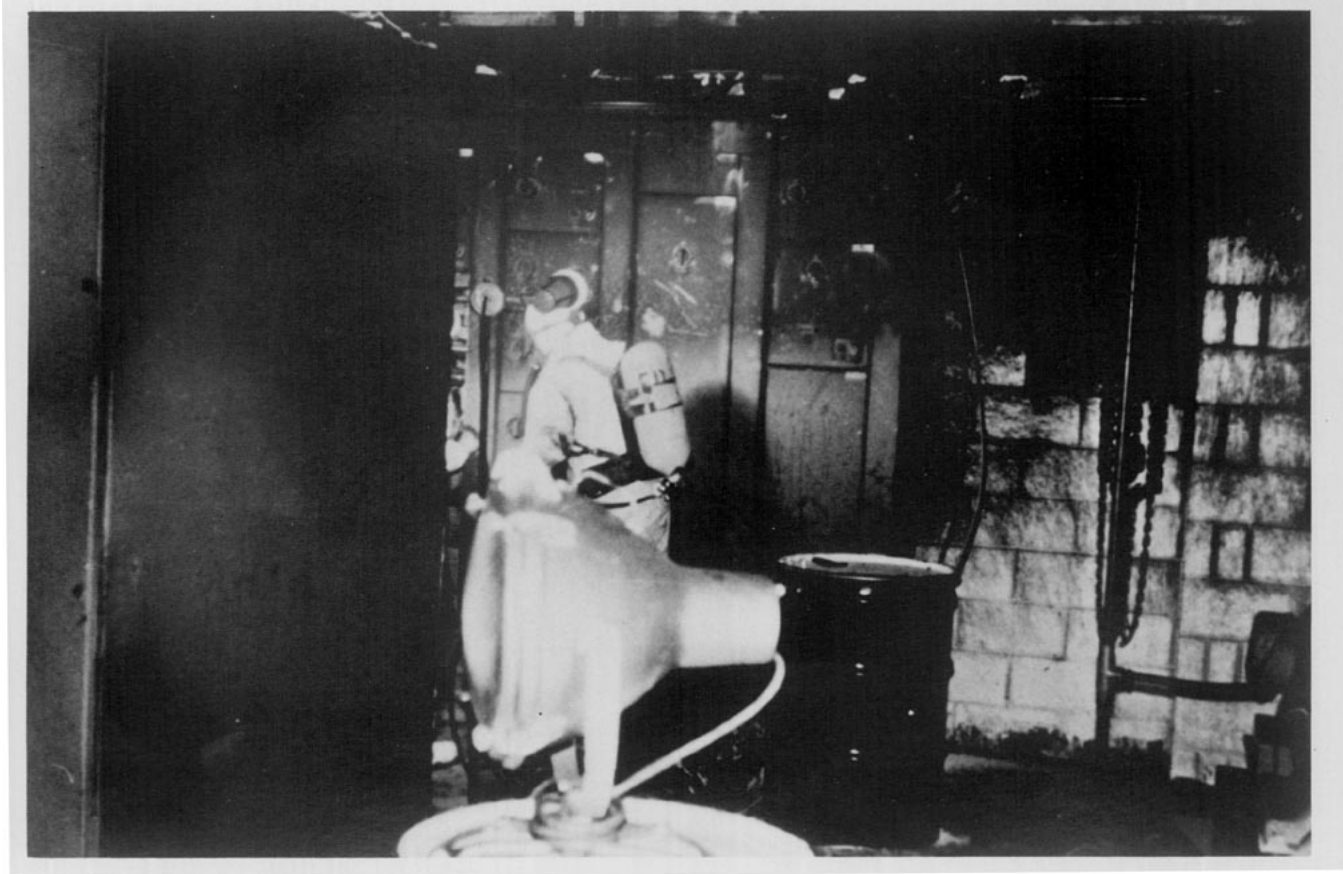
FIGURE 4. A worker wearing full air pack, self-contained breathing apparatus (SCUBA) and full face and body protection is shown working in the transformer room.

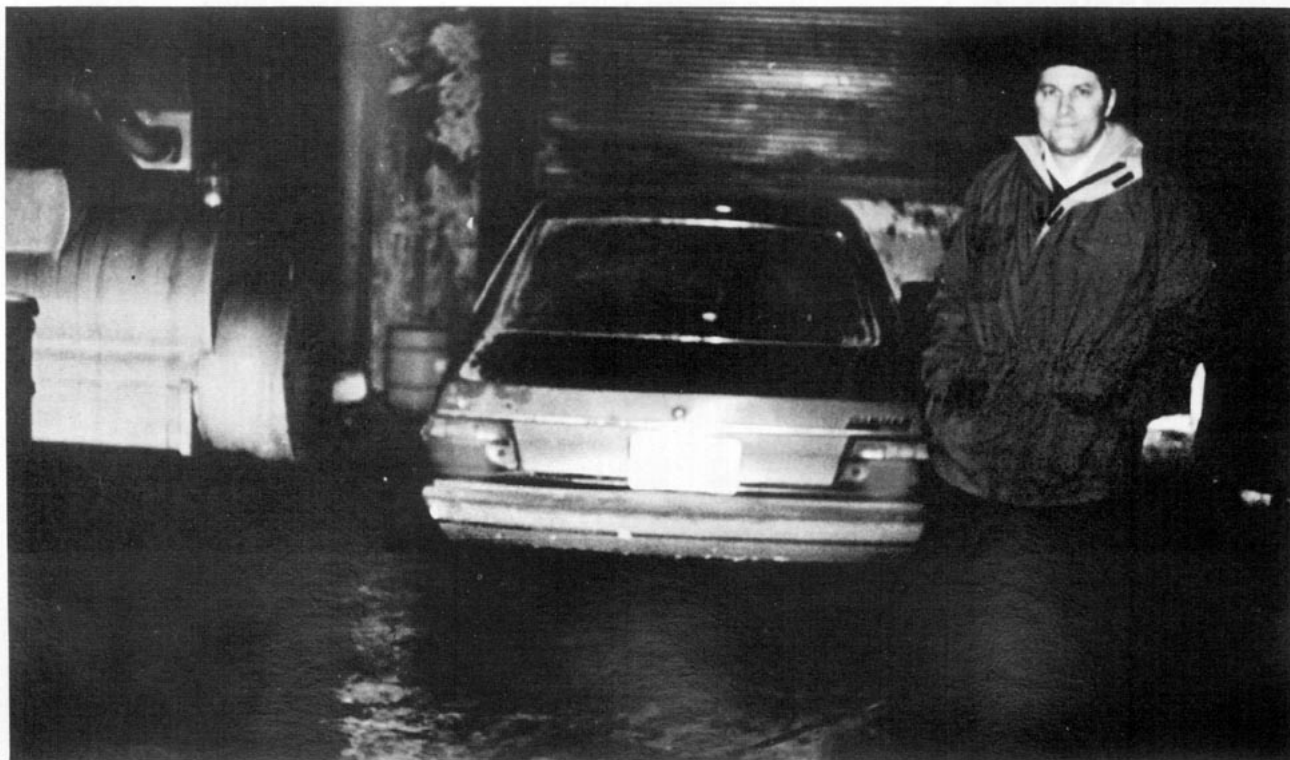
FIGURE 5. An engineer wearing no protective clothing or respirator is shown in a contaminated area. Ingestion of chemical contaminated soot and air is probable through the respiratory, dermal or gastrointestinal routes as is the potential for movement of chemicals to the home via contaminated clothing.

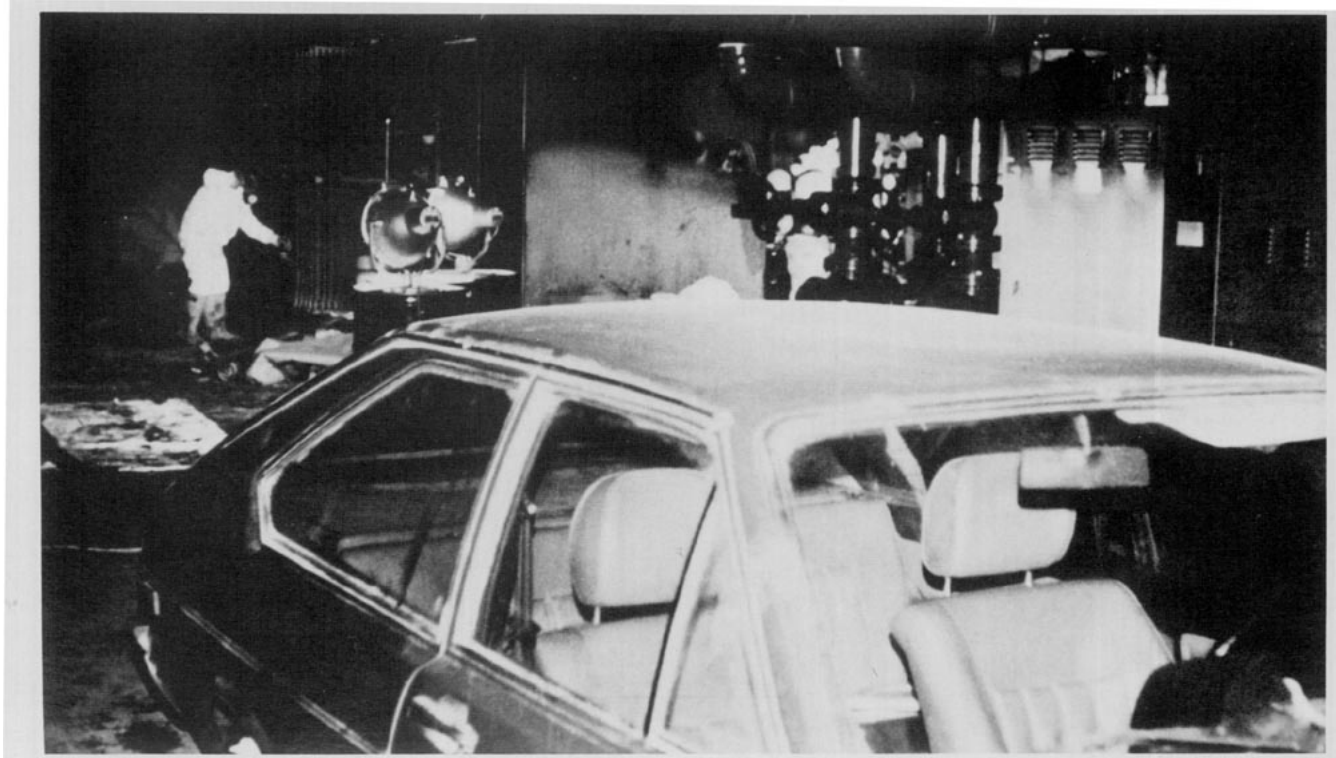
FIGURE 6. A car in the electrical room area was contaminated with PCBs and presumably other chemicals. The PCB contamination which can be visualized on top of the car could not be removed by repeated scrubbing and detergent in steam cleaning. The car was eventually removed to a toxic waste dump.

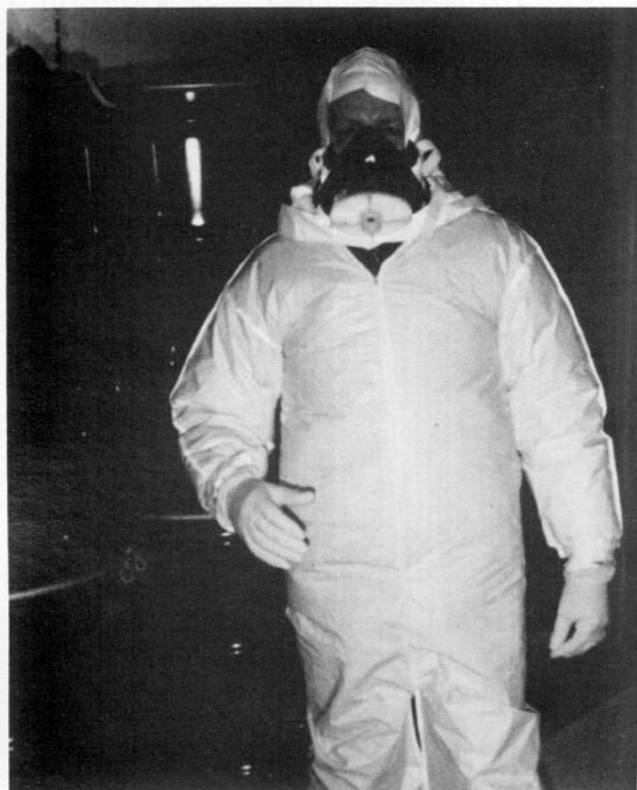
FIGURE 7. Various types of respirators and cartridges were used in the initial clean up during February 1981. Uncovered hair, face and eyes are seen, as is an apparently dust-type respirator as well as partially opened protective clothing over street clothes. Such irregularities document chemical exposure and pose a problem of patient evaluation and medical surveillance for the occupational medicine physician who may be involved afterwards. Direct measures of exposure such as sequential PCB blood or dioxin and furan adipose tissue determination may prove useful to better estimate exposure.

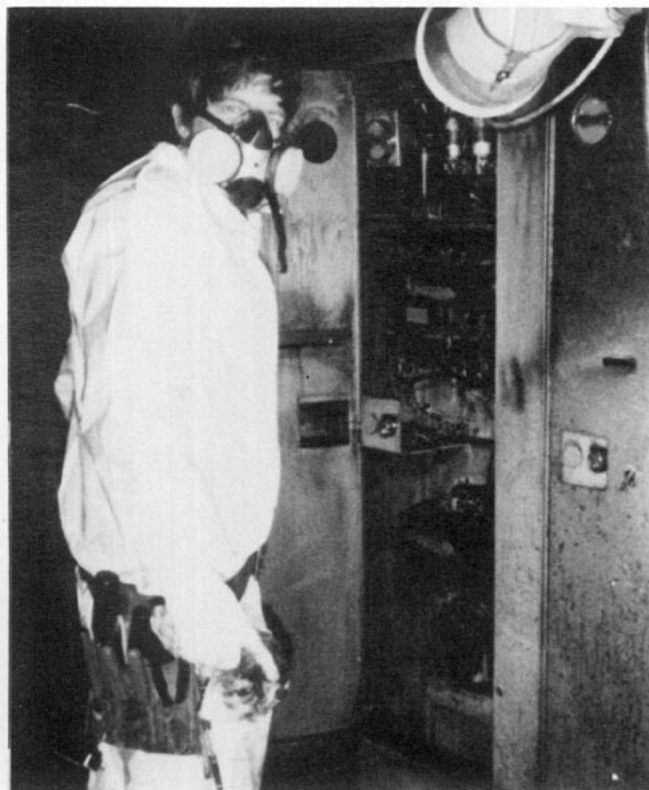
FIGURE 8. Contract electrician wearing street clothes, open protective clothing, a respirator without full face protection and apparently not a NIOSH-approved type of cartridge in his respirator. He later developed skin cancer on an exposed portion of his forehead.

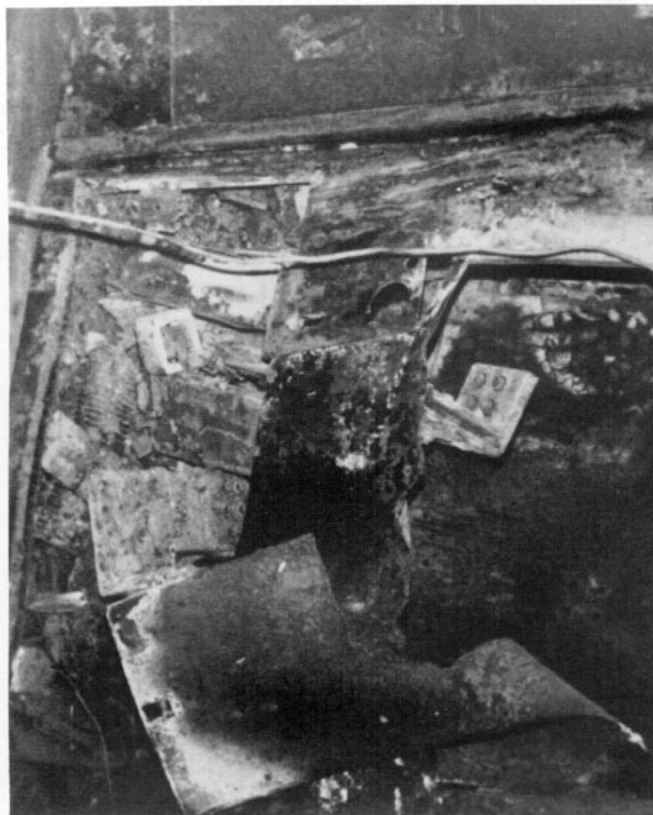
FIGURE 9. Intense heat at the electrical panel produced this damage. Metal panels are destroyed or bent by the heat of the electrical arcing.

Prevention of similar incidents will be of increasing importance in future years. Chemical containment (including no air shafts running from electrical system

rooms) better fuses and circuit breakers, prevention of surges in electricity reaching electrical panels and transformers, rapid methods for extinguishing fires, such as by noncombustible gases now used in some industries, or substitution of non-PCB and nonchlorinated benzene-containing equipment should be considered. The substituted material must also be evaluated for toxicity before replacement of PCB. Last, the health effect of most of these isomers in man is an unknown area, certainly one in which extensive medical research is urgently needed.

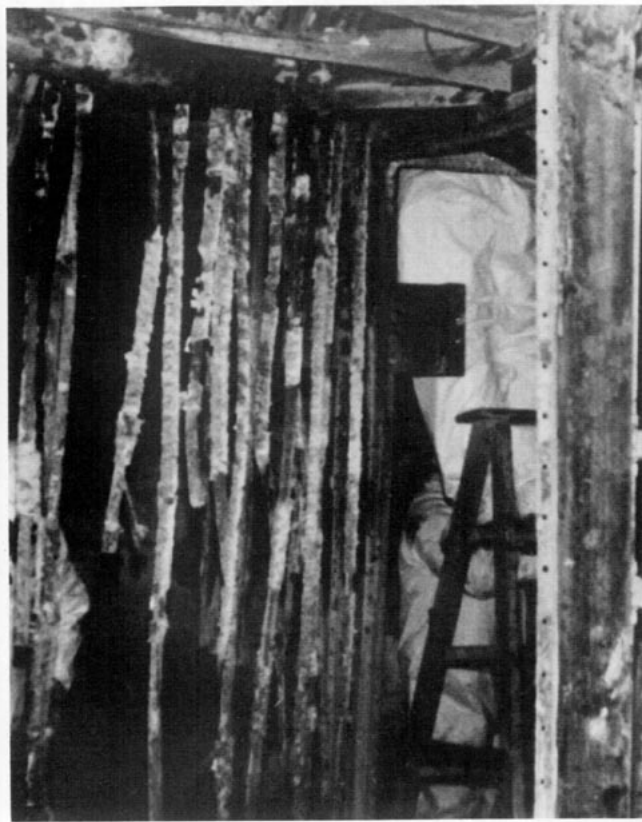
FIGURE 10. The intense heat burned the insulation from these wire cables. This implies other chemicals such as vinyl chloride may have been involved in the initial worker exposure, especially that of firefighters, police and supervisory workers, as well as photographers and other representatives of the press.
